A Walk around Barclay Church
Stewart Tod, September 2005.

A WALK AROUND BARCLAY CHURCH INSIDE.

BARCLAY – INSIDE THE ROOF SPACE.

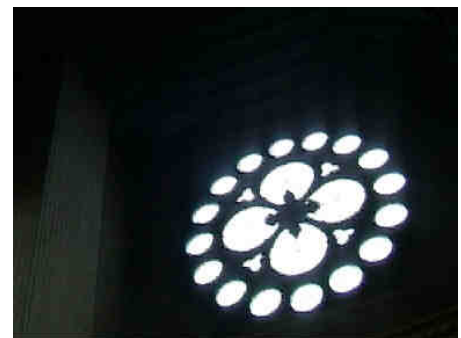
The tower at 250 feet is second only to St.Mary’s Cathedral in height. St.John’s Tolbooth Church, now the Festival Hub, stands higher on the skyline but is less than 200 feet in height. In its original form, the spire had a very elaborate finial, with 3 large gold balls which encouraged some irreverent Victorians to name it “the Pawnbrokers Kirk.” The large golden ornaments came down in the late 1920’s and an eye-witness described to me how amazed he was to discover that each ball was more than a metre in diameter! In recent times, the spire has been inspected and repaired with Historic Scotland grant assistance. The light coloured ring of stone was inserted stone by stone at that time without taking the tower down. There is now additional stainless steel reinforcement within the tower to take the place of iron cramps and dowels which had started to crack some of the stones. If looked down on from above, the various roofs are symmetrical and form a cross, which is remarkable in a building of this kind and since much of the rest of the church is asymmetrical.

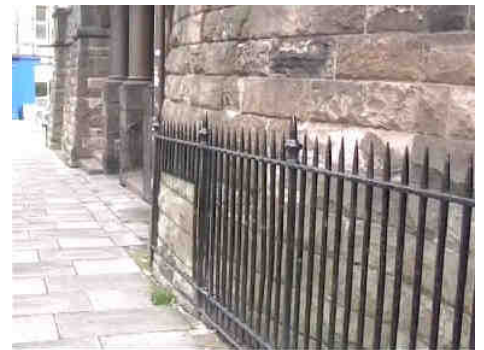
The full extent of the site would have been **fenced** but the section (-now used as a car space by the Minister and others) at the side of the North square would have lost its fence during the 1939-45 war when railings were removed for melting down for armaments. There is still a variation in the paving which indicates the outline of the site. There were 2 large

lamps, one on either side of the main stair. They were removed some years ago when they became dangerous.

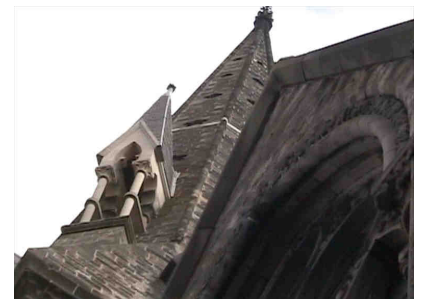
It was on this elevation that the **south-west pinnacle** fell into the street in 1974. We were able to replace it in glass-fibre with assistance from the Edinburgh Planning Committee as our insurance could not pay for its replacement in stone. The plastic replica lasted approximately 25 years until the last phase of the Historic Scotland Grant Scheme which at this stage received assistance from the Baird Trust and the General Trustees of the church, as well as a grant from Edinburgh City as an aid to the preservation of the skyline of the Capital City.

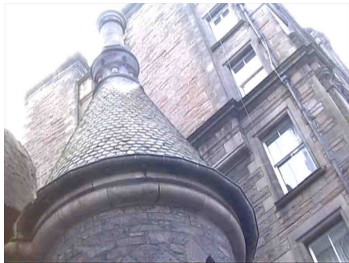
The massive **decorative stone chimney** acting as an apex terminal to the conical slate roof is in the centre of the vestry wing, with a stair down to the boiler and up to the top vestry, the stair winding round the flue.

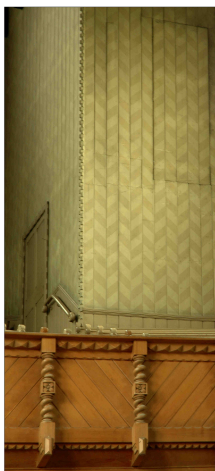
We move now into the **main auditorium** down the centre, which was not possible prior to 2000 as the doors were limited to the 2 side doors and 2 other small doors at the extreme back corners. The **pews** extended right to the back of the church, so there was always fun trying to synchronise the entry of parades from the 2 main doors to arrive at the sanctuary together. Another hazard was the very low front edge of the balcony which made it quite difficult for Boy's Brigade, Guides etc entering with flags on 7 foot long poles! The pews were removed entirely from the centre section and the sanctuary extended outwards with the moving of the organ – all in the 2000 scheme. This arrangement made possible the formation of the present **spiral staircases** into the upper gallery which had previously been accessed from the very steep and slightly dangerous staircase, which is now not used at all (-except for special access to the top gallery).

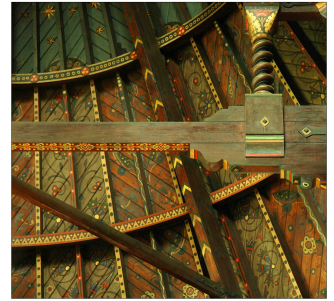
The **ceiling** has some painted timberwork and the slightly splayed ceiling which we see was fitted after the opening of the church to reduce heat loss and noise from rattling slates.

There is a small opening in this ceiling which is accessible from within the roof space. A dramatic floor plan of the church can be produced by a photograph from that opening. The **lights** have to be lowered by pulley in the roof space for the changing of bulbs. At one

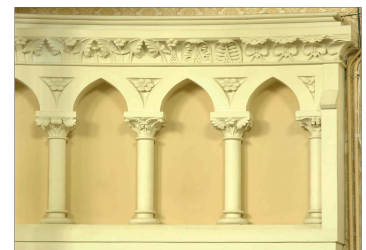
The **balcony front** with barley sugar posts is typical of the period. Elsewhere the **plastering and carvings** are interesting in that, although they balance, they **do not in fact match exactly** –they are simply similar. In Victorian times it was more economical to give good craftsmen complete freedom to interpret, rather than to slavishly copy which required much

measurement and checking. The interior gives the impression of symmetry about the pulpit and the entrance axis but if you glance at the windows on either side and at the length of the balcony beyond the large pillars, you will see how **asymmetrical** the building really is. This is caused by the usable area of the auditorium extending right to the boundary of the site on east and west.

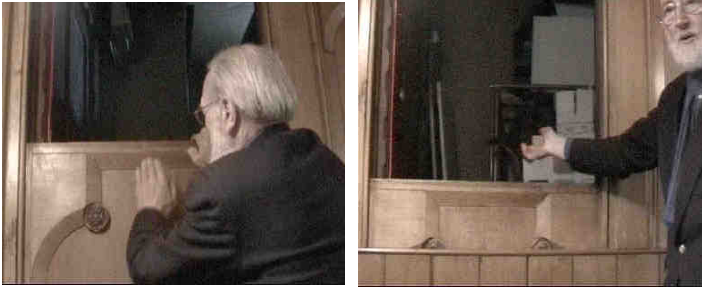
At the back of the front gallery we have a feature similar to the sliding windows in the Pillar Hall. All of the **panels along the back** slide down to provide “standing viewing” from within the Gents Cloakroom (-truly a coat room and no toilet facilities).

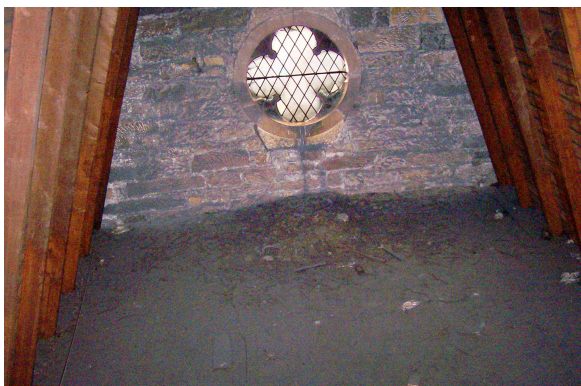
Go back to the centre point of the roof and there are to right and left the “transept roofs” which each have a light fitting and each can be lowered from this level using a pulley to ground level where bulbs are changed.
